**EVALUATION OF CRACK SEALING COMPOUNDS
FOR ASPHALTIC PAVEMENTS**

EMO PROJECT NO. 33

Final Report

**Engineering Materials Office
Highway Engineering Division
Ministry of Transportation & Communications**

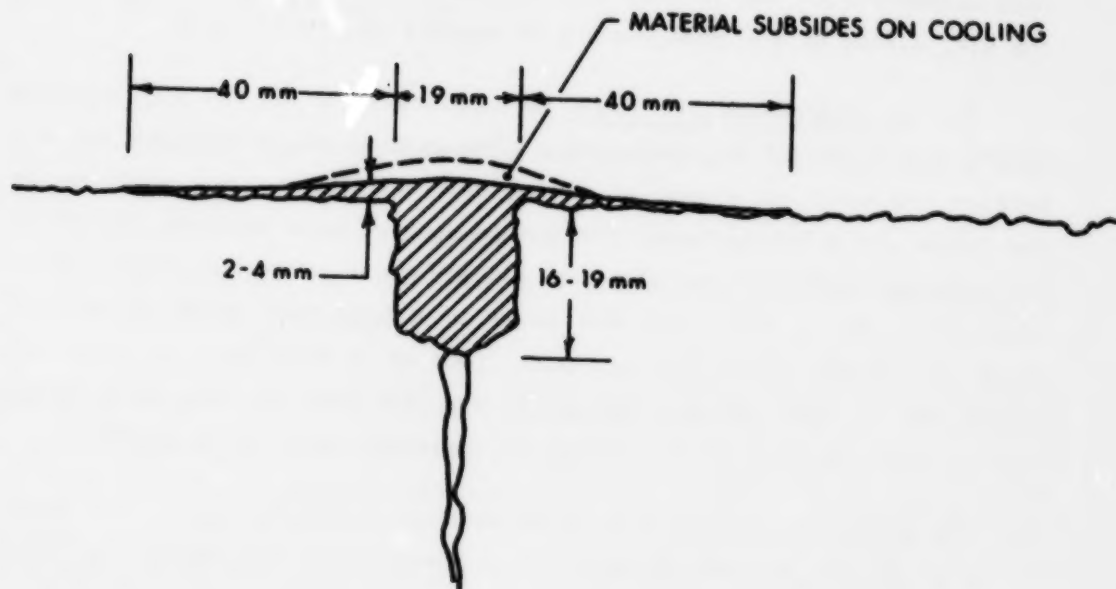
FIGURE 2

The desired cross section of seal in a routed groove is as shown in Figure 2. Most of the strike off devices used just levelled the sealant but the "U" and "V" shaped squeegees with a crescent cut out of the rubber at the back gave the desired cross section to the sealant. The sealant needs to be struck off so as to leave a bead of material over the routed groove with the edges of the material feathered out. The bead of material will flatten out considerably after subsiding into the crack and through thermal shrinkage. If the sealant stands too proud of the surface, it is subject to snow plough damage. Due to either inappropriate strike off devices or lack of operator skill, lumps of sealant were left proud of the pavement surface at the ends of cracks or where a crack changed direction. This material created a noticeable bump which will likely be cut off in the winter by snow plowing operations, with the risk that additional material may be pulled out of the sealed crack.

DESIRED CROSS-SECTION OF ROUTED AND SEALED CRACK

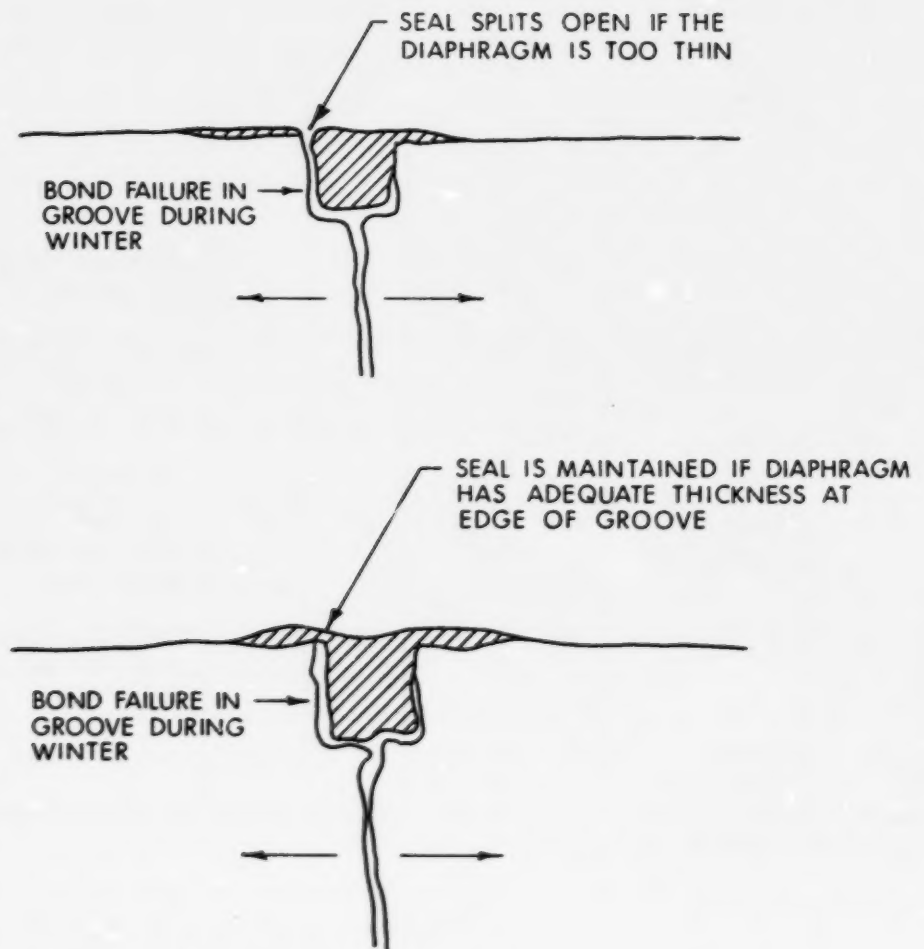
FIGURE 3

During the four appraisals it became evident that splitting of the seals at the edge of the rout was minimized if the membrane at that point had a 2-3 mm cross-sectional thickness. Where the sealant was struck off thin, (less than 1 mm) poor performance was common. In several sections it was noted that an effective seal was maintained even though the material was no longer bonded in the routed groove as confirmed by pinching the seal between thumb and forefinger and lifting it up and down. This occurred when the diaphragm across the rout had enough cross-sectional area to maintain its integrity. Figure 3 indicates how the cross-section of the seal can affect winter performance.

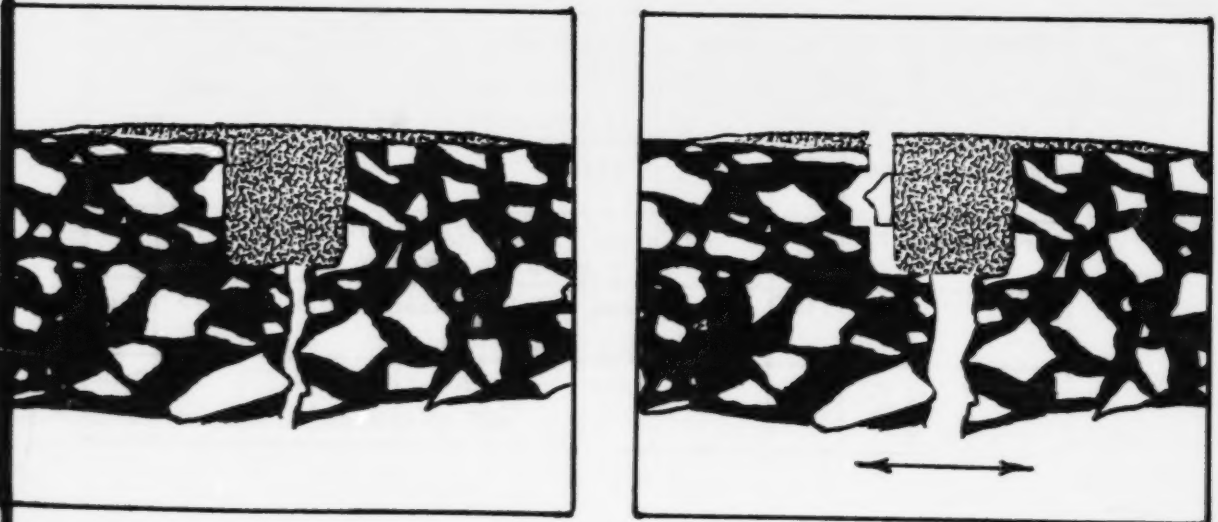
FIGURE 4
GENESIS OF A "BOND" FAILURE

The work in 1981 and 1982 established that seals fail primarily in bond and that if moisture was present at the time of routing and sealing, bond failure was almost assured. To clarify, separation or splitting of a seal at the edge of the routed groove has been identified as a bond failure. This is a somewhat oversimplified description because the actual failure may be a combination of bond/cohesive failure plus a partial failure of the pavement. Sealants with a good bond and high stiffness modules will pull aggregate that have been disturbed in the cutting operation out of the side of the routed groove. This was observed in many of the test sections. Figure 4 demonstrates how a "bond" failure may be a combination of failures.

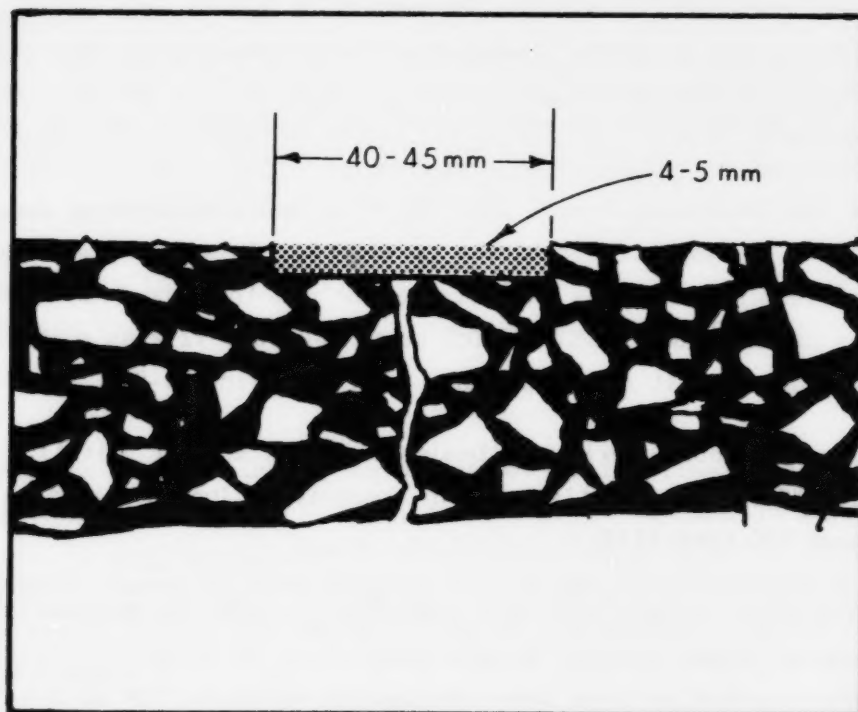
FIGURE 4

Several trial installations have been constructed in 1983 using a method introduced to the Ministry by Klaruw of Holland (Fig.4). This method has the advantage of the overband seal without the hazard of snow plow damage. These installations will be reviewed over the winter of 83-84.

KLARUW METHOD
